2.0 WITHOUT PROJECT CONDITIONS

2.1 STUDY AREA DESCRIPTION

2.1.3 PROJECT SITE

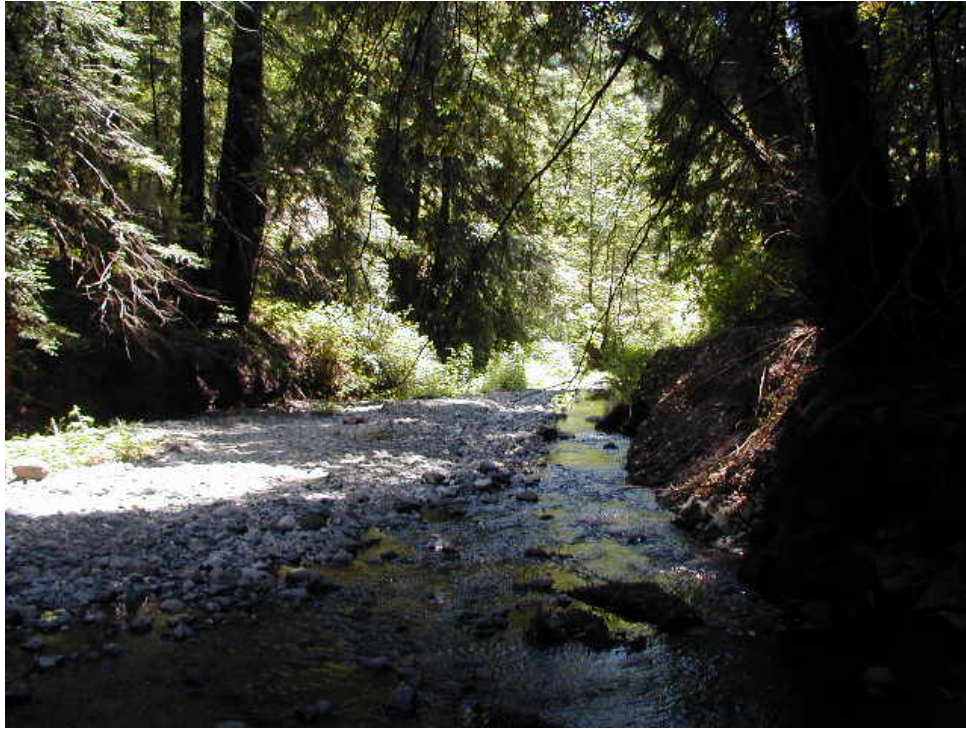
Figure 2.1 York Creek Natural Condition (Approximately 700 feet upstream of Dam).

The Upper York Creek Ecosystem Restoration Project is within the five-square-mile York Creek drainage basin and is located northwest of the city of St. Helena, Napa County, 60 miles north of San Francisco (See Figure 1.1). Figure 2.1 shows York Creek approximately 700 feet upstream of Upper York Creek Dam.

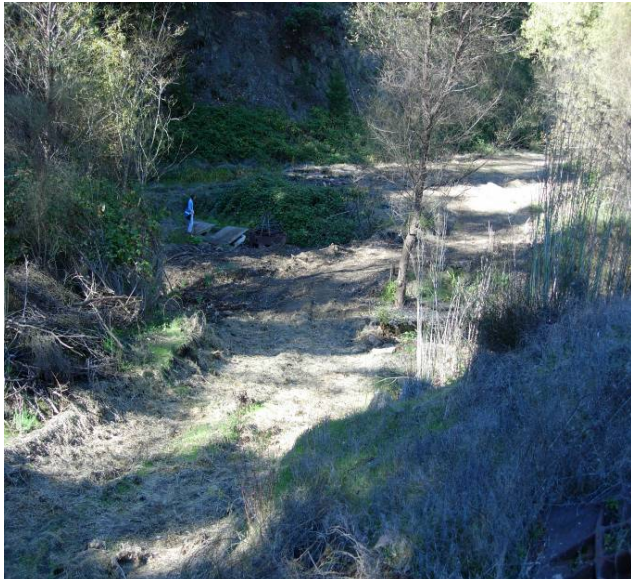
Figure 2.3 Upper Reservoir in dry conditions
(November 17, 2005)

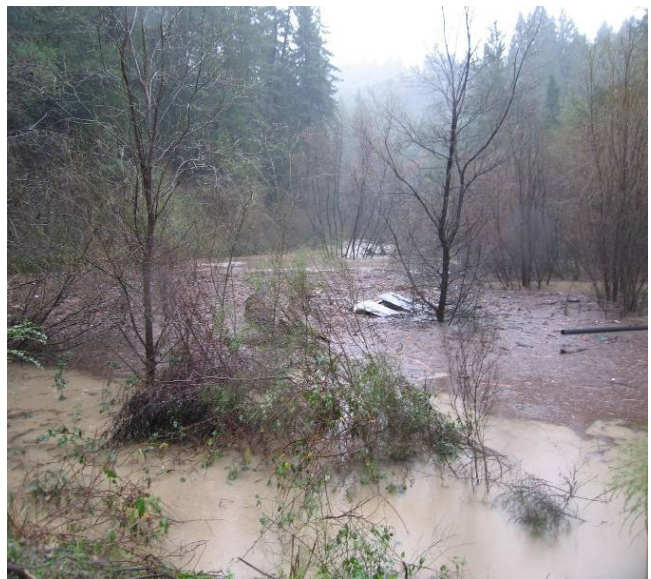
Figure 2.4 Upper Reservoir in Storm
Conditions. (January 1, 2006)

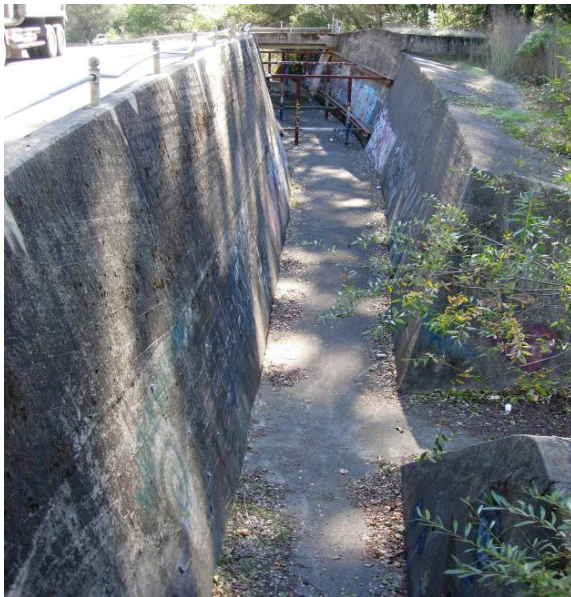
Figure 2.5 Spillway in dry conditions
(November 17, 2005)

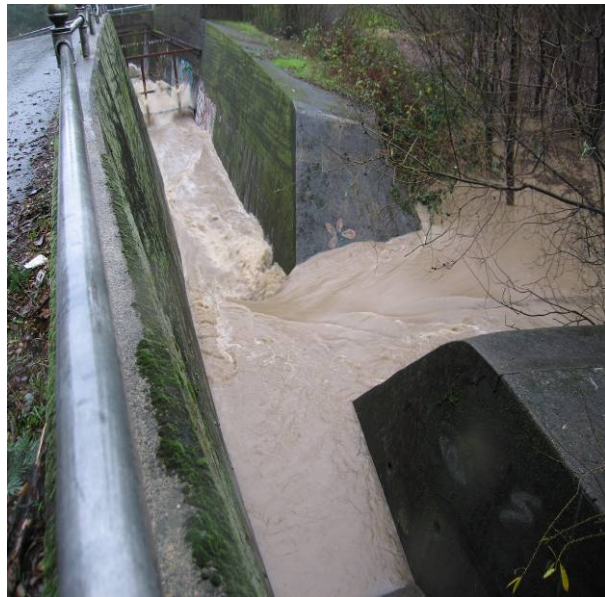
Figure 2.6 Spillway in Storm Conditions.
(January 1, 2006)

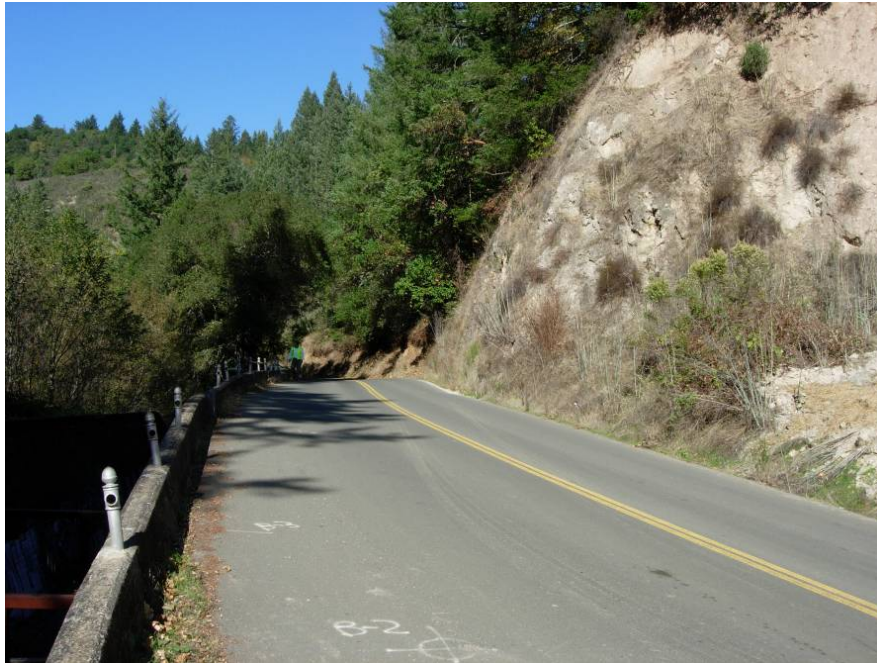
Figure 2.7 Spring Mountain Road Facing Upstream. (Spillway located to left of road).

There is an observed ground movement in the project area. It is bounded by the hillside to the east, Spring Mountain Road in the middle portion and the spillway and the dam towards to the west. The exact reason for the movement is unknown.
